FIRE RISK ASSESSMENT

**The Granary
Wroxall Manor Farm
Manor Bottom
Manor road
Wroxall
PO38 3DH**

Date of Survey 29th April 2019

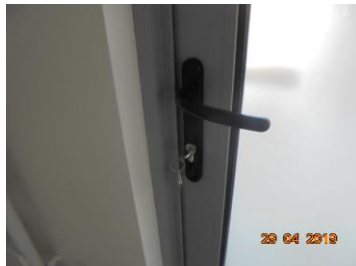
a) locks to internal door and gate currently locked by key

Final Exits can be opened without the need for a key in an emergency (Advised that thumbturns were due to be fitted).
